**United States Environmental Protection Agency
Region III
Waste & Chemicals Management Division
RCRA Compliance & Enforcement Branch
Wheeling Office**

Narrative Subtitle I Inspection Report

On October 20, 2003, EPA Waste & Chemicals Management Division conducted an underground storage tank ("UST") inspection of the Dairy Mart #6 located at 1205 Dorsey Avenue in Morgantown, West Virginia. The facility is identified by West Virginia ID# 3103960. The purpose of this inspection was to determine the facility's compliance under Subtitle I of the Resource Conservation & Recovery Act ("RCRA"). All information included in this report are the results of statements by the facility representatives, materials shown to the inspector by facility representatives during and subsequent to the inspection, and a review of EPA and state records.

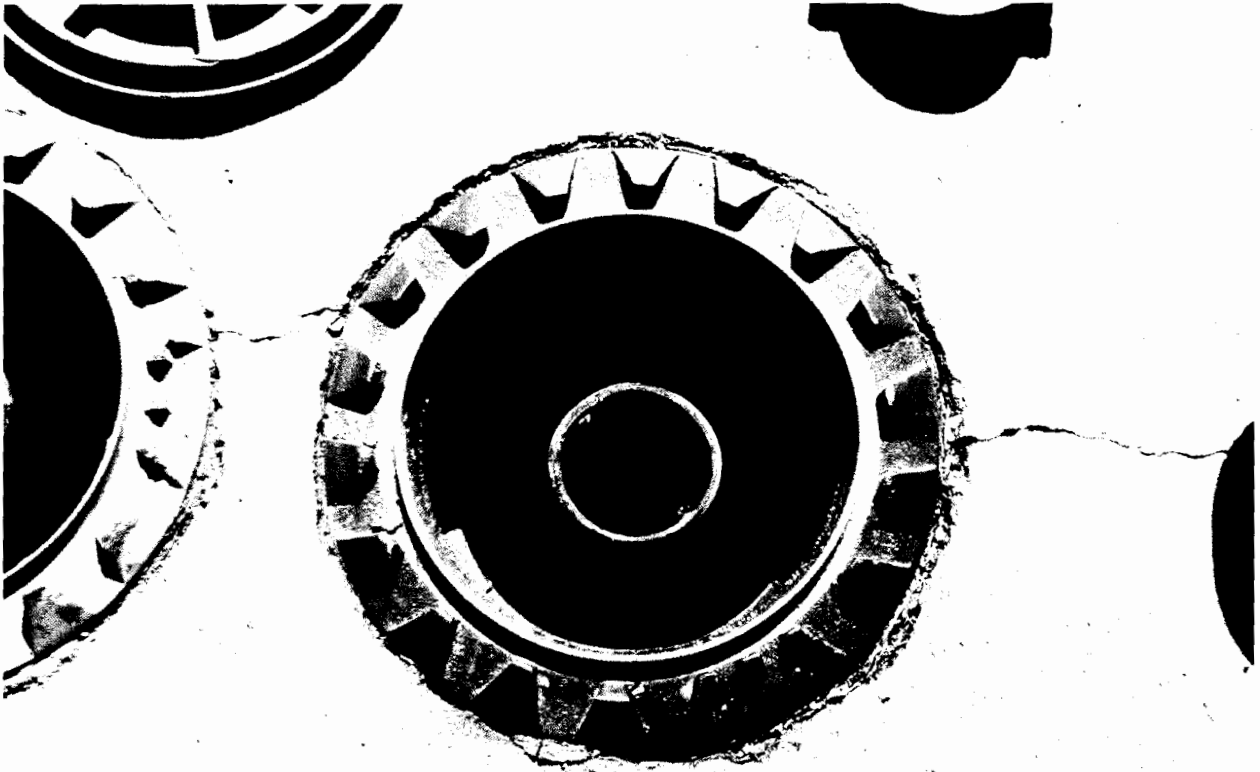
Dairy Mart #6
Morgantown, WV
ID #3-103960
Inspected: October 20, 2003
Inspector: Clark S. Conover
EPA/RIII/Wheeling
Photo#: 4

The facility has spill buckets installed on each fill point (Photos # 4,8,14&20) and a ball float valves installed as overfill protection in fill tubes for all compartments (Attachment 6). All tanks appear to be in compliance with overfill protection conducted in accordance with 40 C.F.R. § 280.20(c)(ii)(A) and spill protection conducted in accordance with 40 C.F.R. § 280.20(c)(i); as required by 40 C.F.R. § 280.21(d).

This photo depicts the fill point for compartment 1A.

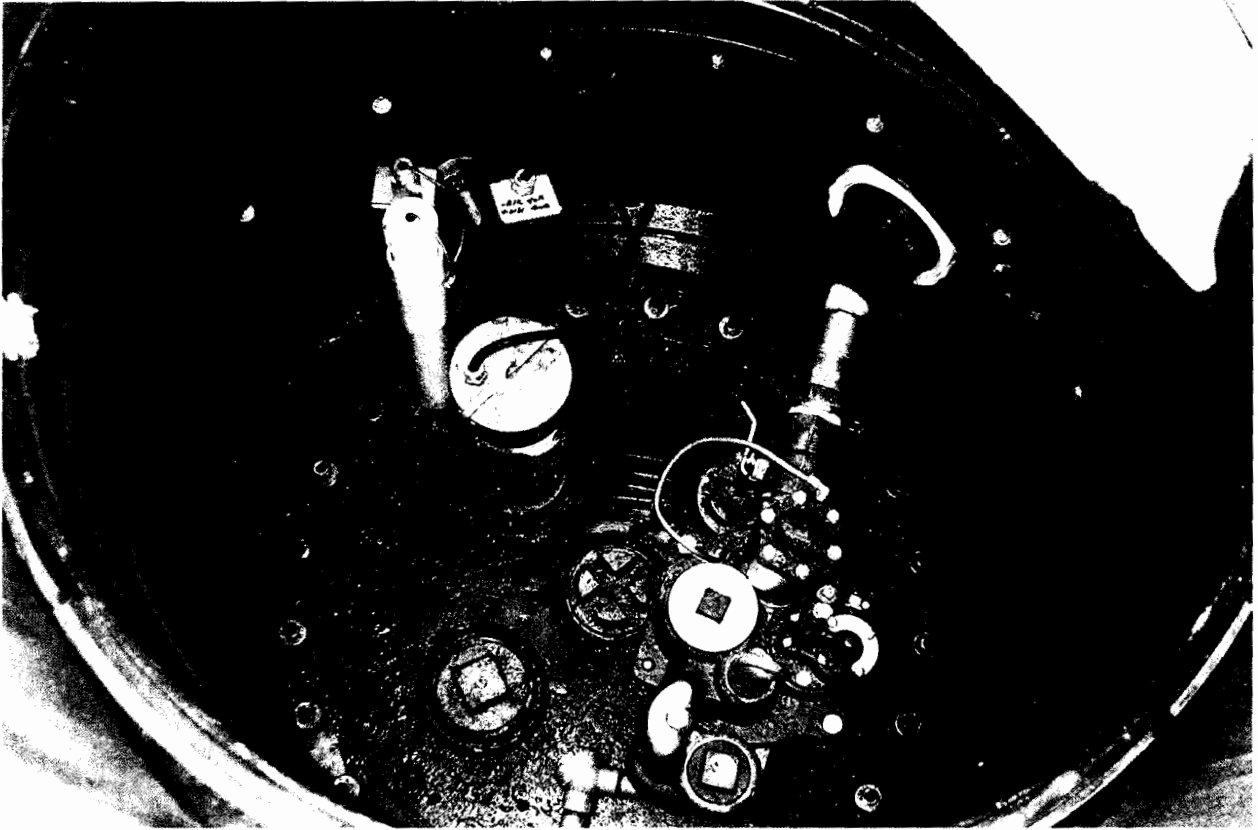
Dairy Mart #6
Morgantown, WV
ID #3-103960
Inspected: October 20, 2003
Inspector: Clark S. Conover
EPA/RIII/Wheeling
Photo#: 7

The submersible pump attached to each of the tank's compartments is located in a self contained sump (Photos #7,12,17& 23), and was not in contact with soil and/or water. Each sump is also equipped with a sensor which will detect the presence of fuel in the sump. The facility claims that any leak in the inner line will be contained by the secondary containment system and then will spill back in the sump setting off the sump alarm. The owner's representative stated that the company utilizes this as their form of line leak detection in accordance with 40 C.F.R § 280.44(c) (Attachment 4). When requested for the last sump sensor test the company provided a test conducted on October 27, 2003.

Attached to the pump of each compartment is a line leak detector; however, the company was unable to provide any documentation that the line leak detectors have been tested within the previous 12 months and there have been no line tightness tests. 40 C.F.R § 280.44 is a list of the methods to conduct line leak detection, in order to meet the requirements of 40 C.F.R § 280.41. 40 C.F.R § 280.41(b)(1) provides that all pressurized piping be equipped with line leak detectors conducted in accordance with 40 C.F.R § 280.44(a), which requires an annual test. In addition to the requirement for a line leak detector the pressurized lines must either undergo an annual line tightness test conducted in accordance with 40 C.F.R § 280.44(b) or have monthly monitoring conducted in accordance with 40 C.F.R § 280.44(c). 40 C.F.R § 280.44(c) authorizes any method in 40 C.F.R § 280.43(e)-(h) to be utilized to meet this portion of the line leak detection requirements. The interstitial monitoring method being utilized appears to meet the requirement of 40 C.F.R § 280.43(g).

This photo depicts the pump atop compartment 1A.

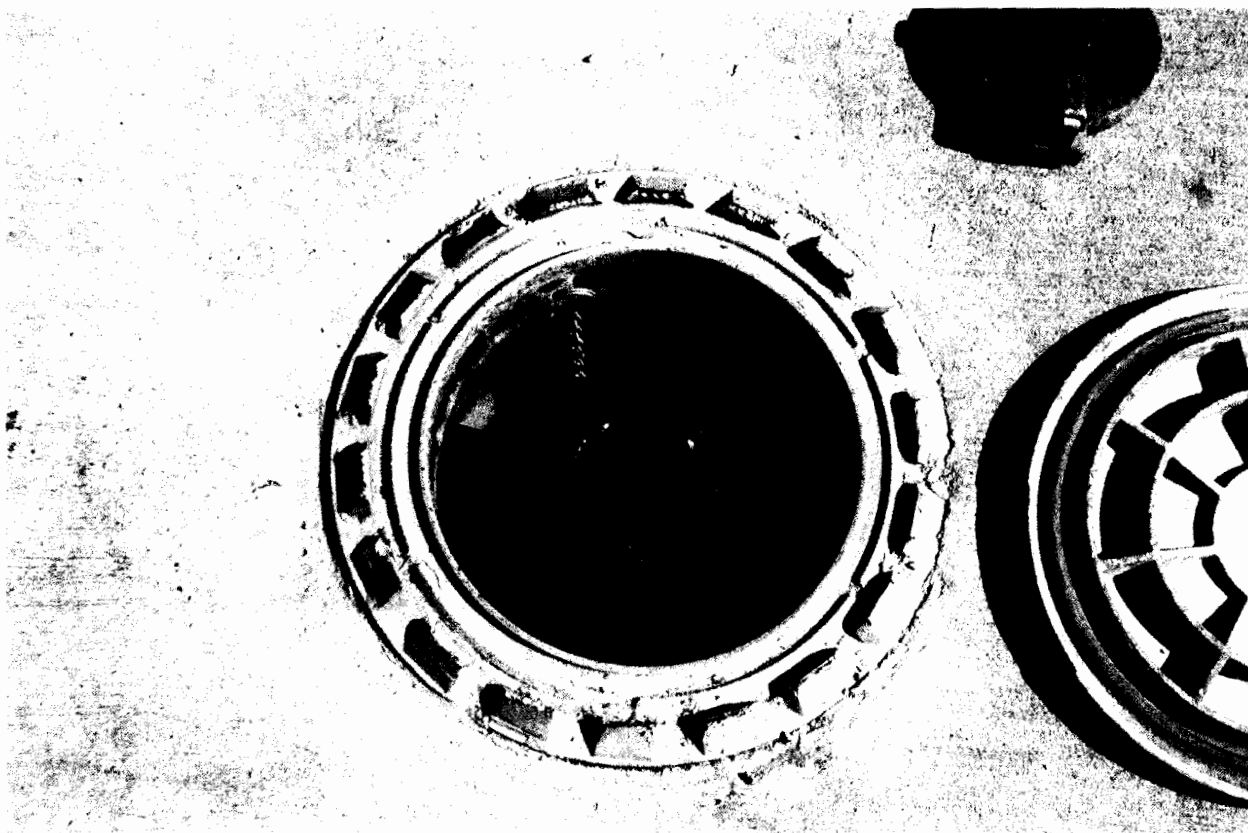
Dairy Mart #6
Morgantown, WV
ID #3-103960
Inspected: October 20, 2003
Inspector: Clark S. Conover
EPA/RIII/Wheeling
Photo#: 9

This photo depicts the broken vapor recovery port for tank 2.

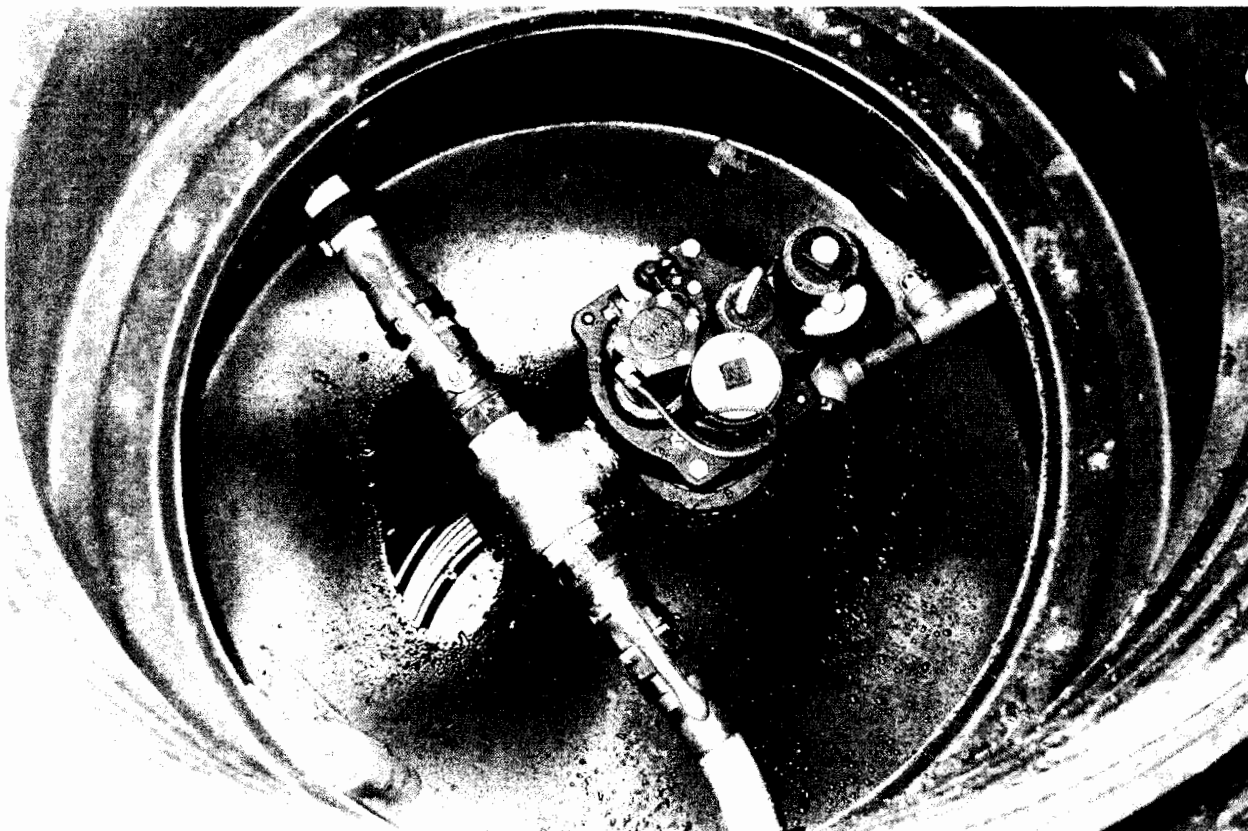
Dairy Mart #6
Morgantown, WV
ID #3-103960
Inspected: October 20, 2003
Inspector: Clark S. Conover
EPA/RIII/Wheeling
Photo#: 12

This photo depicts the pump atop tank #2.

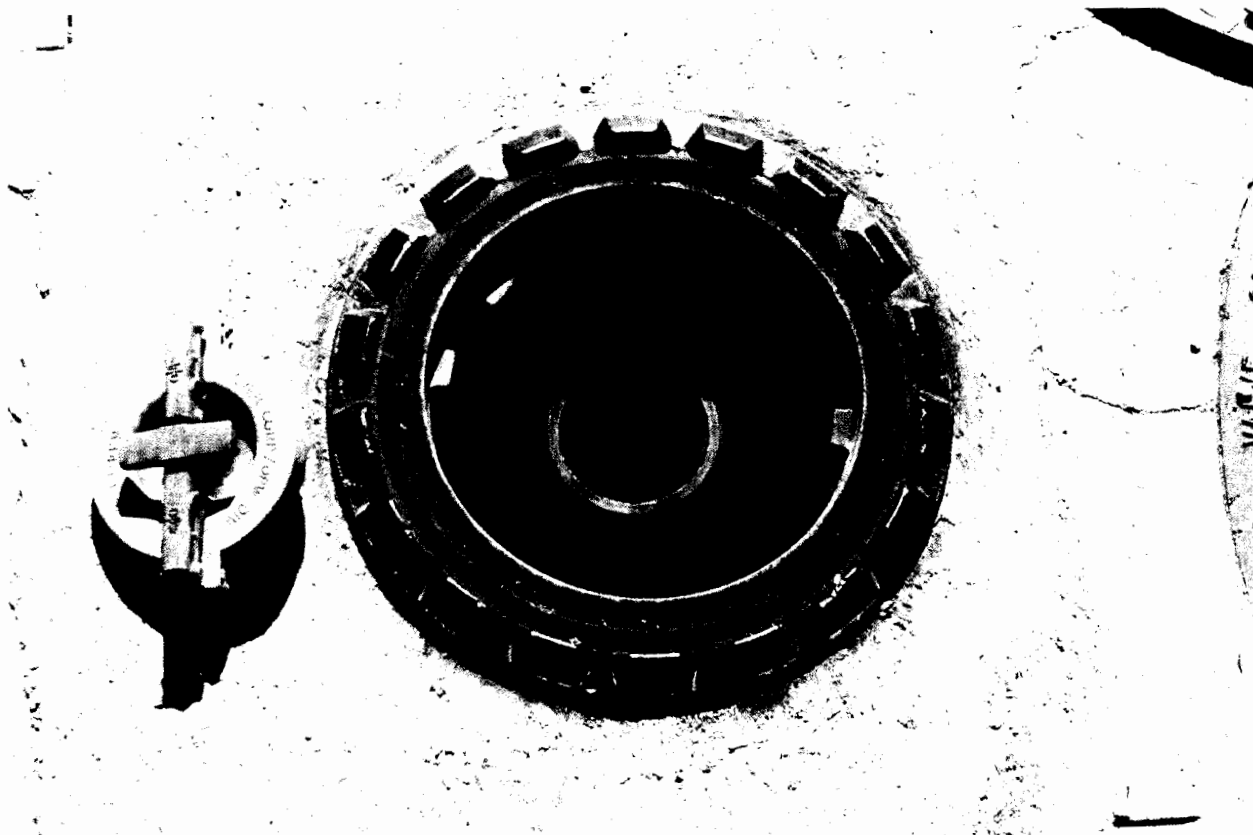
Dairy Mart #6
Morgantown, WV
ID #3-103960
Inspected: October 20, 2003
Inspector: Clark S. Conover
EPA/RIII/Wheeling
Photo#: 14

This photo depicts the fill point for compartment 1B.

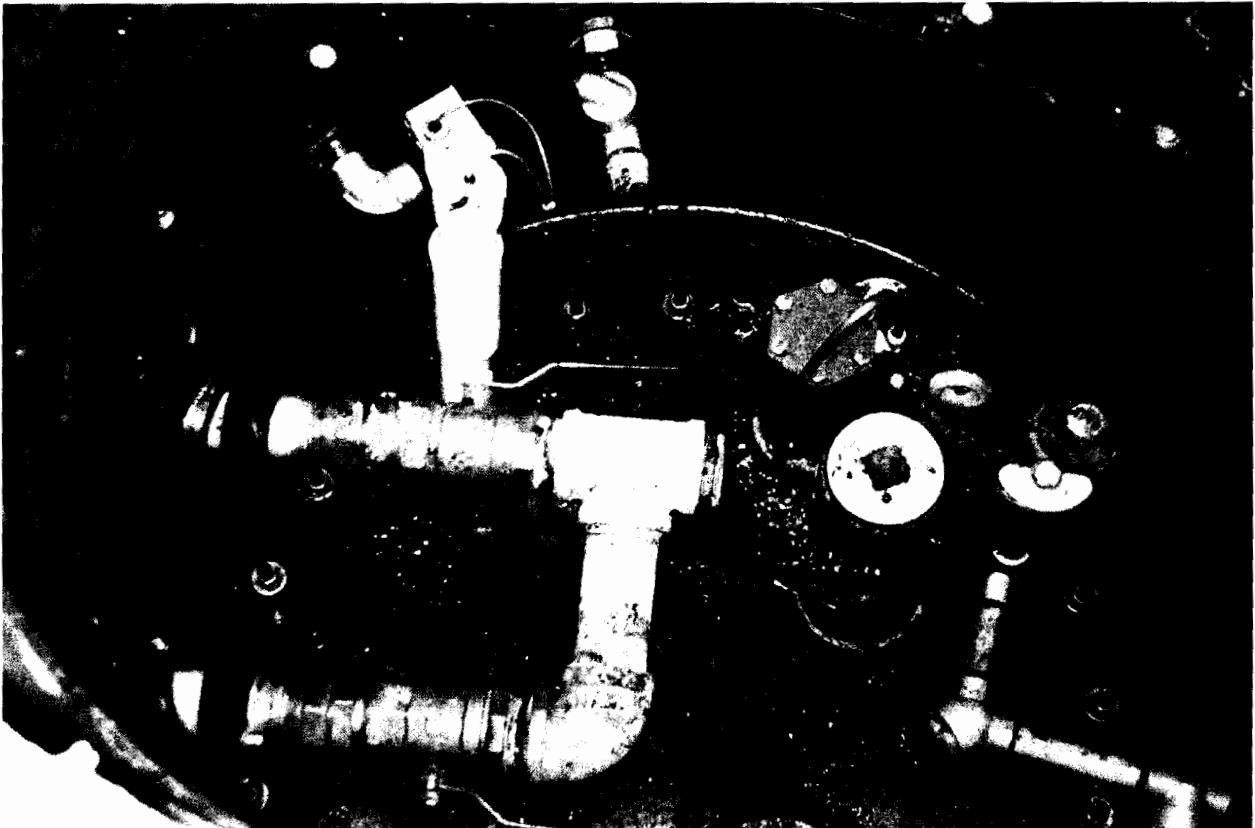
Dairy Mart #6
Morgantown, WV
ID #3-103960
Inspected: October 20, 2003
Inspector: Clark S. Conover
EPA/RIII/Wheeling
Photo#: 17

This photo depicts the pump atop compartment 1B.

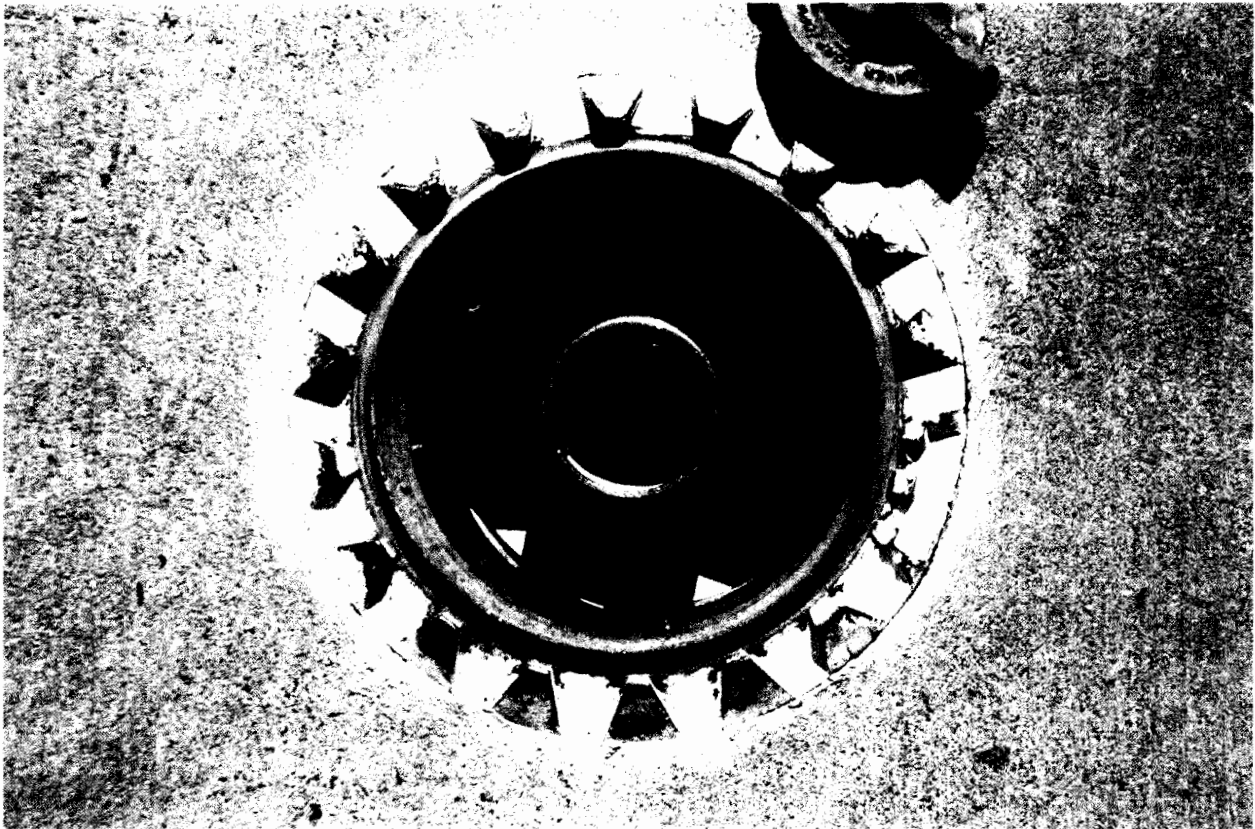
**Dairy Mart #6
Morgantown, WV
ID #3-103960
Inspected: October 20, 2003
Inspector: Clark S. Conover
EPA/RIII/Wheeling
Photo#: 20**

This photo depicts the fill point on tank #3.

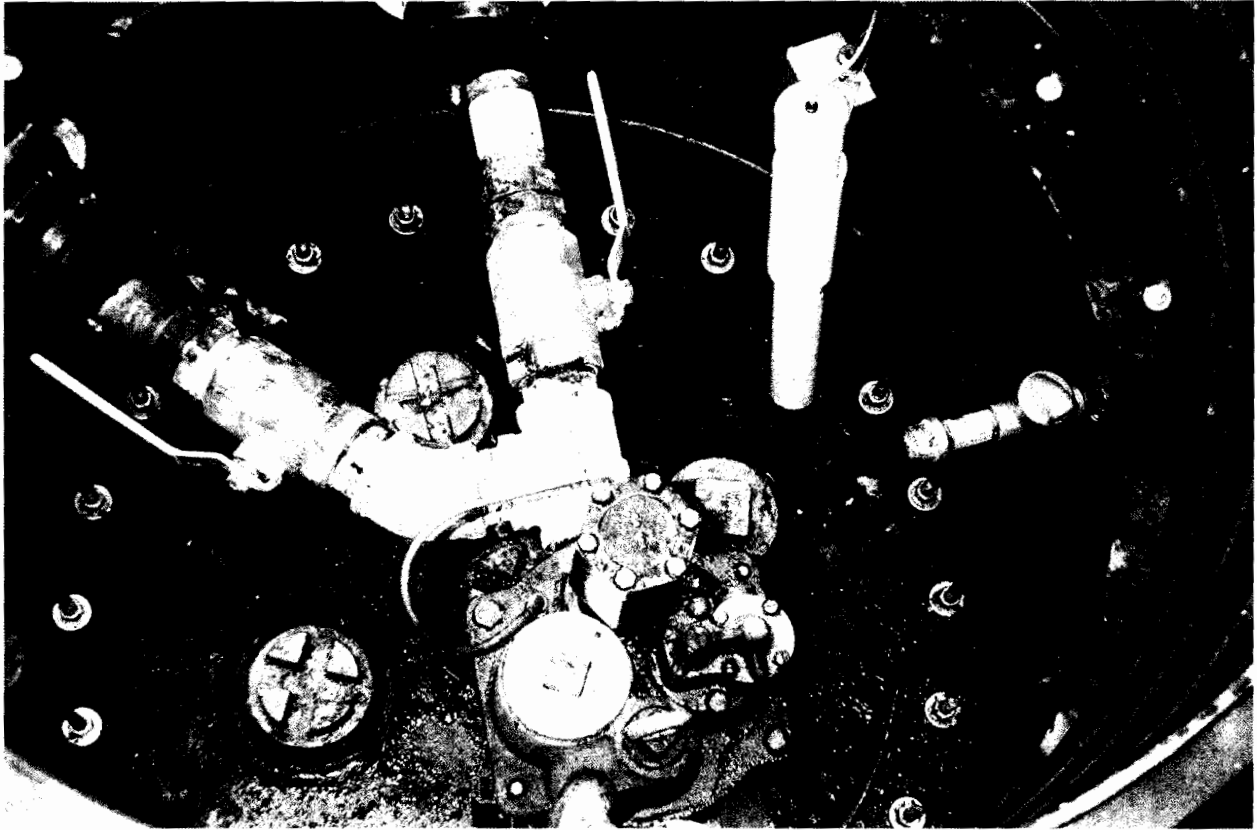
**Dairy Mart #6
Morgantown, WV
ID #3-103960
Inspected: October 20, 2003
Inspector: Clark S. Conover
EPA/RIII/Wheeling
Photo#: 23**

This photo depicts the pump sump atop tank #3.
